BRUSHY CREEK TAILINGS DAM

MO 30951

PHASE I INSPECTION REPORT
NATIONAL DAM SAFETY PROGRAM
BRUSHY CREEK TAILINGS DAM - MO. 30951

Name of Dam:	Brushy Creek Tailings Dam
State Located:	Missouri
County Located:	Reynolds County (Mark Twain National Forest)
Stream:	Schoolhouse Branch of Bill's Creek
Date of Inspection:	15 November 1978

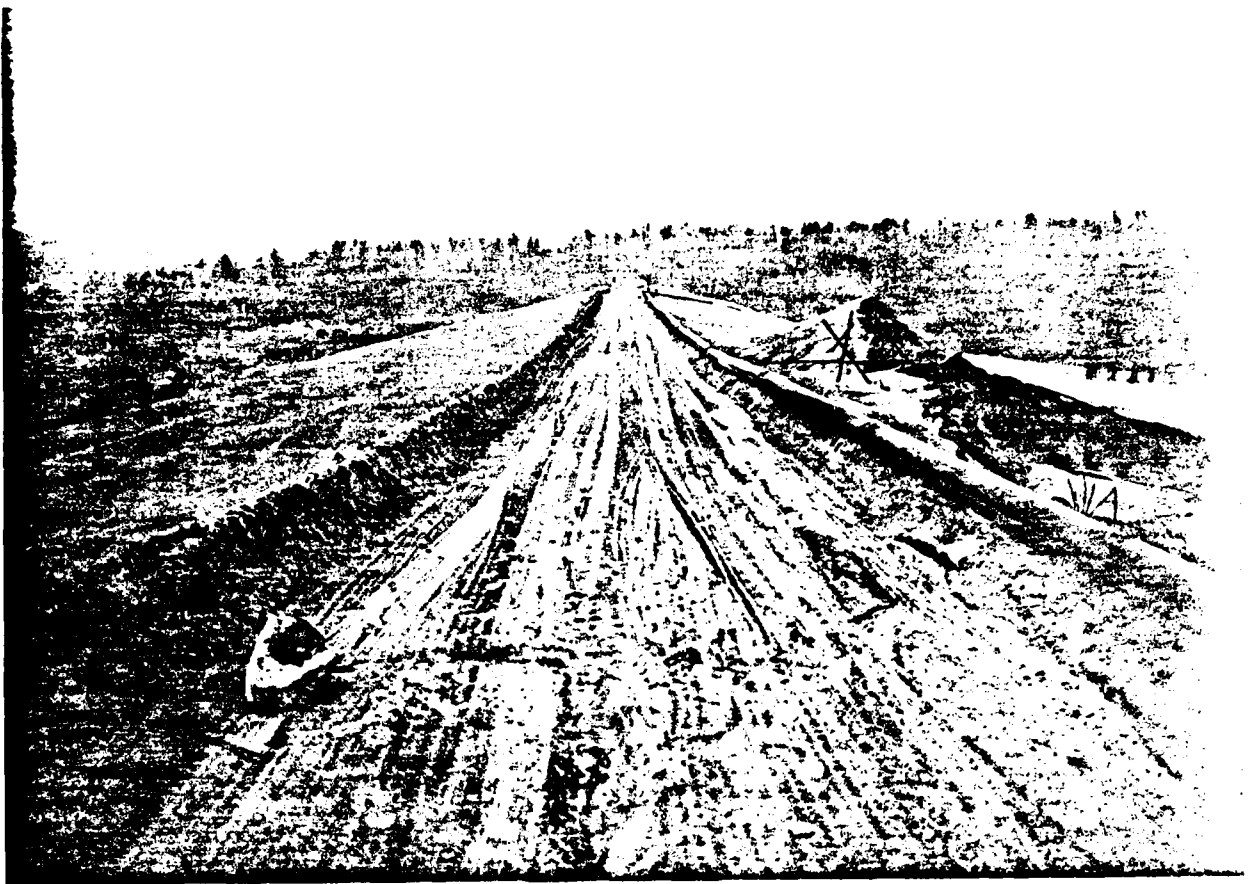
Overview of Brushy Creek Tailings Dam Looking From Southeast Abutment.

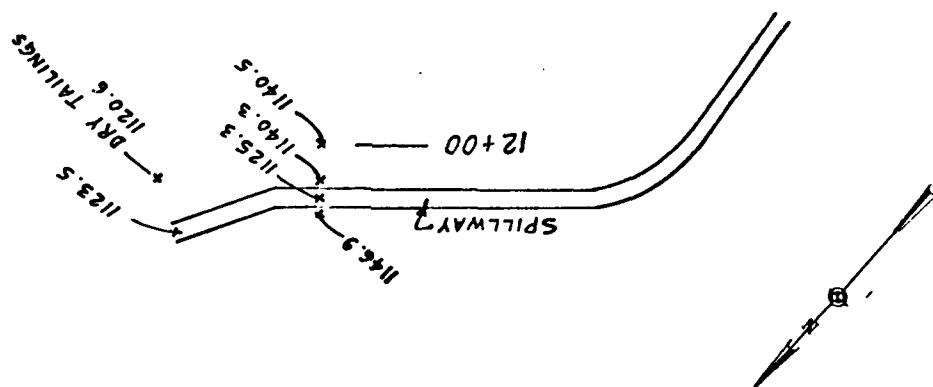
BRUSHY CREEK
TAILINGS DAM
CROSS SECTION
PLATE 5

The upstream slope is more variable than the downstream slope. As seen in Plate 5, the slope is generally near 1V on 4H. However, it is locally steeper. Wind erosion is evident by the formation of a bulging drift on the upstream side of the embankment crest. This drift has resulted from winds blowing from the downstream portion of the valley. Photos 4 and 5 show the undercutting and vertical scarp formations which occur on the upstream slope due to material deposition in fluid form. This has occurred at several locations across the length of the dam. Southeast of the valley centerline there is an erosion channel from the crest upstream to the reservoir
